Case Study – 12” Pipe x 1 ft Repair near Flange

Cooling Tower Line Repair
Delaware, USA

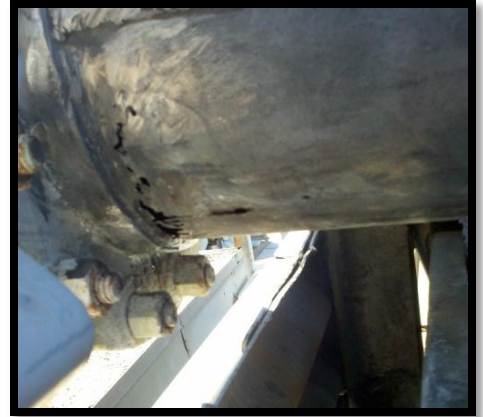
The repair of thru wall defects near flange on a 12” carbon steel cooling tower waterline operating at 140 psi and 90°F.

View of Thru wall defects

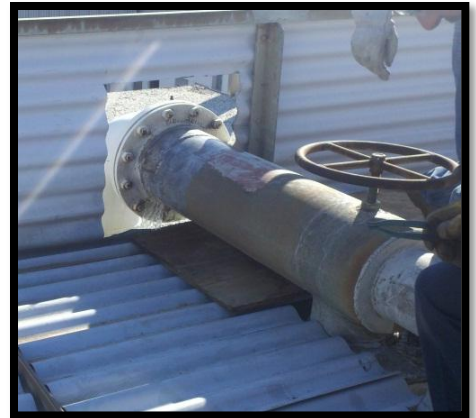
Pipe prepped for repair

- Grinded all surfaces to clean steel
- Installed ¼' thick piece of rubber stopgap over defects. The rubber pieces were secured with galvanized banding strap. Traditional method of repair (filling pipe with putty stick) was not used due to extremely thin bottom.

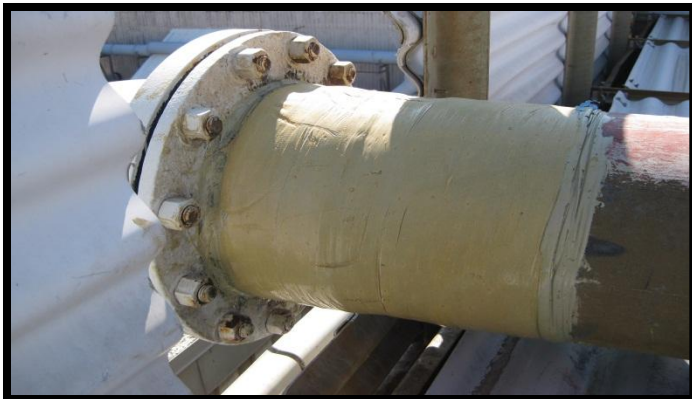
View of Completed Repair

- Two rolls were used making the repair six layers thick. A spiral wrap was done overlapping 2” of the hoop wrap with 3 rolls of material over the rest of the repair.

- Constrictor Wrap was applied over the material. Line was recharged 2 hours after completion. The temperature was of an estimated 78 degrees.

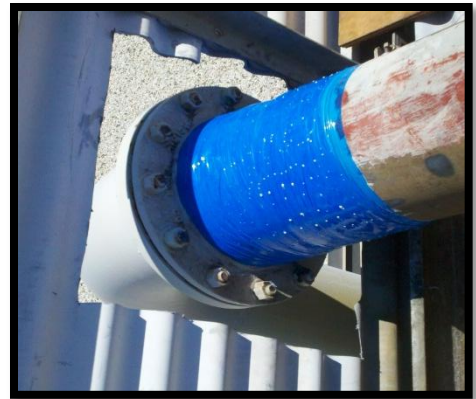
Repair Applied and Curing
